# New Hampshire Volunteer Lake Assessment Program

## 2003 Interim Report for Baxter Lake Farmington

# OBSERVATIONS & RECOMMENDATIONS

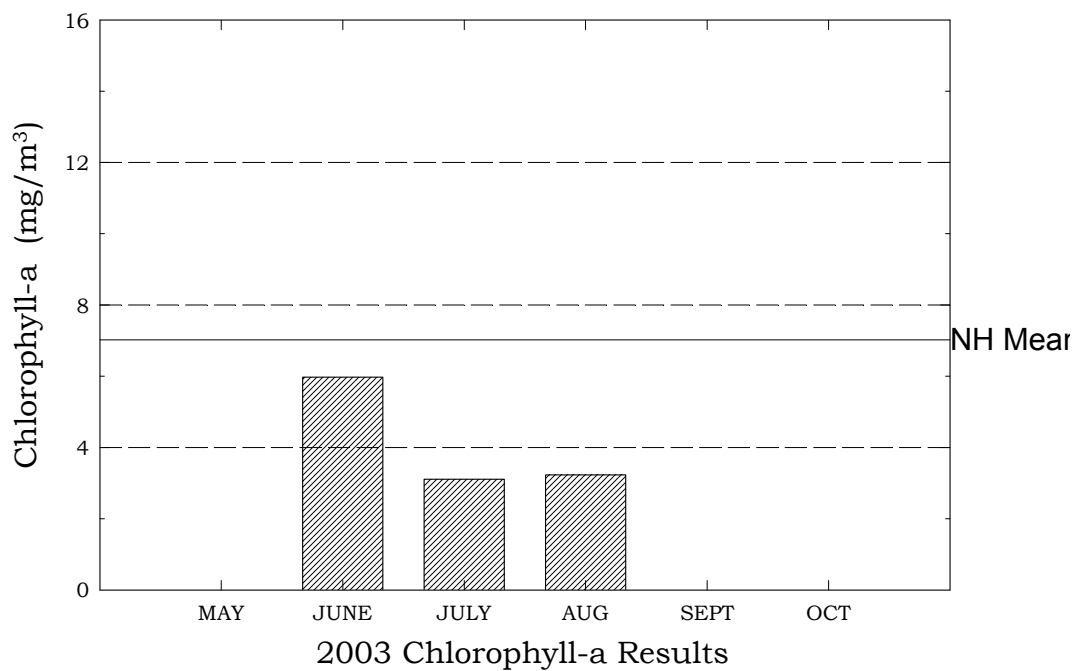
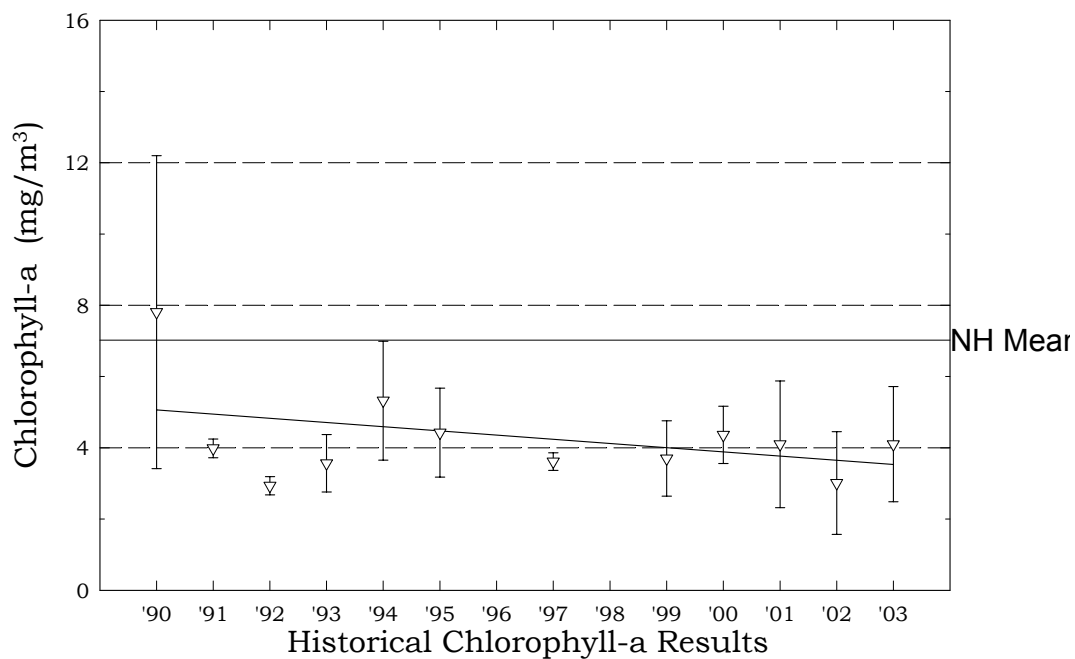
**Figure 1.** Monthly and Historical Chlorophyll-a Results

The current year data (the top graph) show that the chlorophyll-a concentration **decreased** from June to July, and then **remained stable** from July to August. The chlorophyll-a concentration on each sampling event was **less than** the state mean.

Overall, visual inspection of the historical data trend line (the bottom graph) shows **a relatively stable** in-lake chlorophyll-a trend, meaning that the concentration has **remained approximately the same** since monitoring began in 1990. After 10 consecutive years of sample collection, we will be able to conduct a statistical analysis of

While algae are naturally present in all lakes/ponds, an excessive or increasing amount of any type is not welcomed. In freshwater lakes/ponds, phosphorus is the nutrient that algae depend upon for growth. Algal concentrations may increase with an increase in nonpoint sources of phosphorus loading from the watershed, or in-lake sources of phosphorus loading (such as phosphorus releases from the sediments). Therefore, it is extremely important for volunteer monitors to continually educate residents about how activities within the watershed can affect phosphorus loading and lake quality.

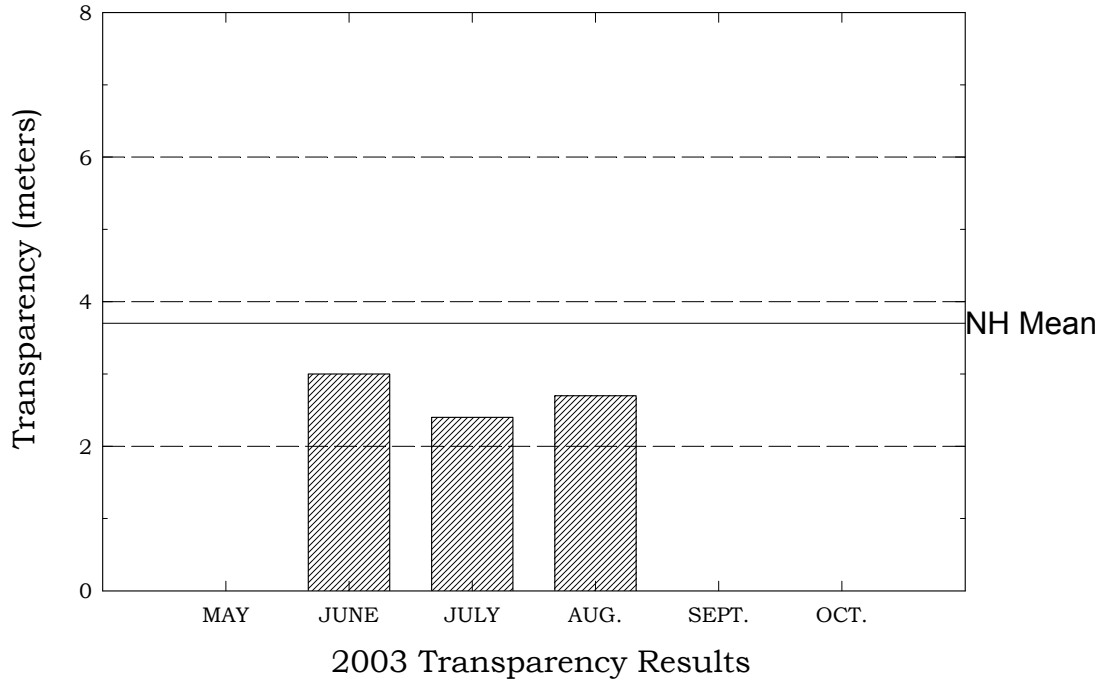
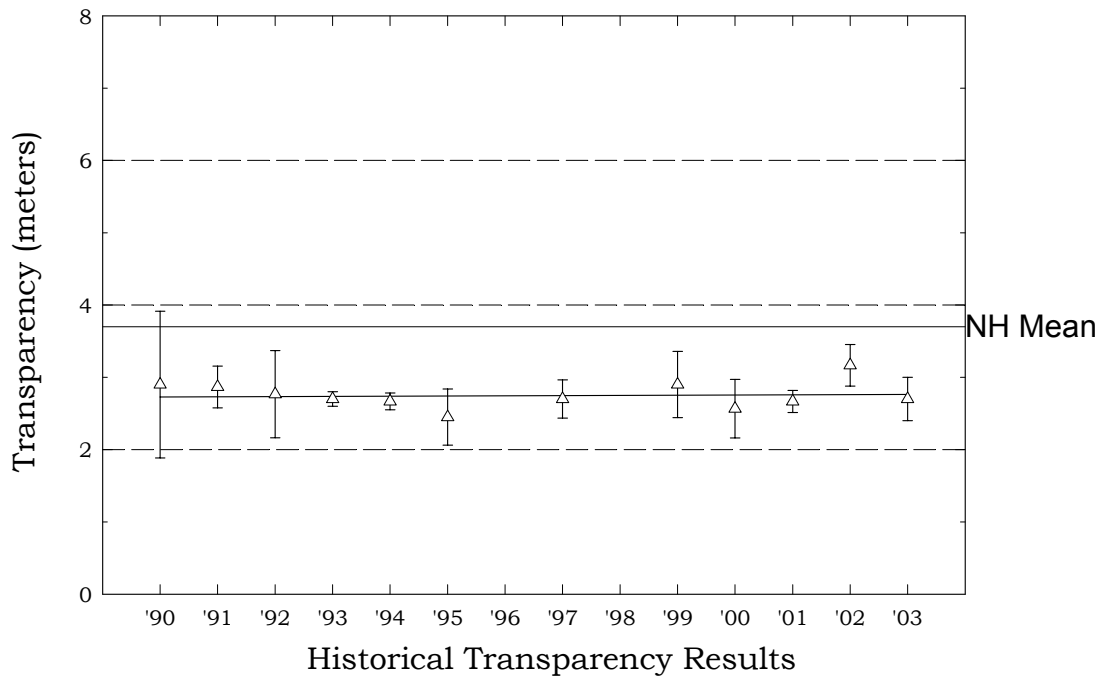
**Figure 2.** Monthly and Historical Transparency Results

The current year data (the top graph) show that the in-lake transparency **decreased slightly** from June to July, and then **increased slightly** from July to August. The transparency on each sampling event was **less than** the state mean.

Overall, visual inspection of the historical data trend line (the bottom graph) shows **a stable** trend for in-lake transparency, meaning that the transparency has **remained approximately the same** since monitoring began in 1990. After 10 consecutive years of sample collection, we will be able to conduct a statistical analysis of the historic data to objectively determine if there has been a significant change in the annual mean transparency since monitoring began.

Typically, high intensity rainfall causes erosion of sediments into lakes/ponds and streams, thus decreasing clarity. Efforts should continually be made to stabilize stream banks, lake shorelines, disturbed soils within the watershed, and especially dirt roads located immediately adjacent to the edge of tributaries and the lake. Guides

to Best Management Practices designed to reduce, and possibly even eliminate, nonpoint source pollutants, such as sediment loading, are available from DES upon request.

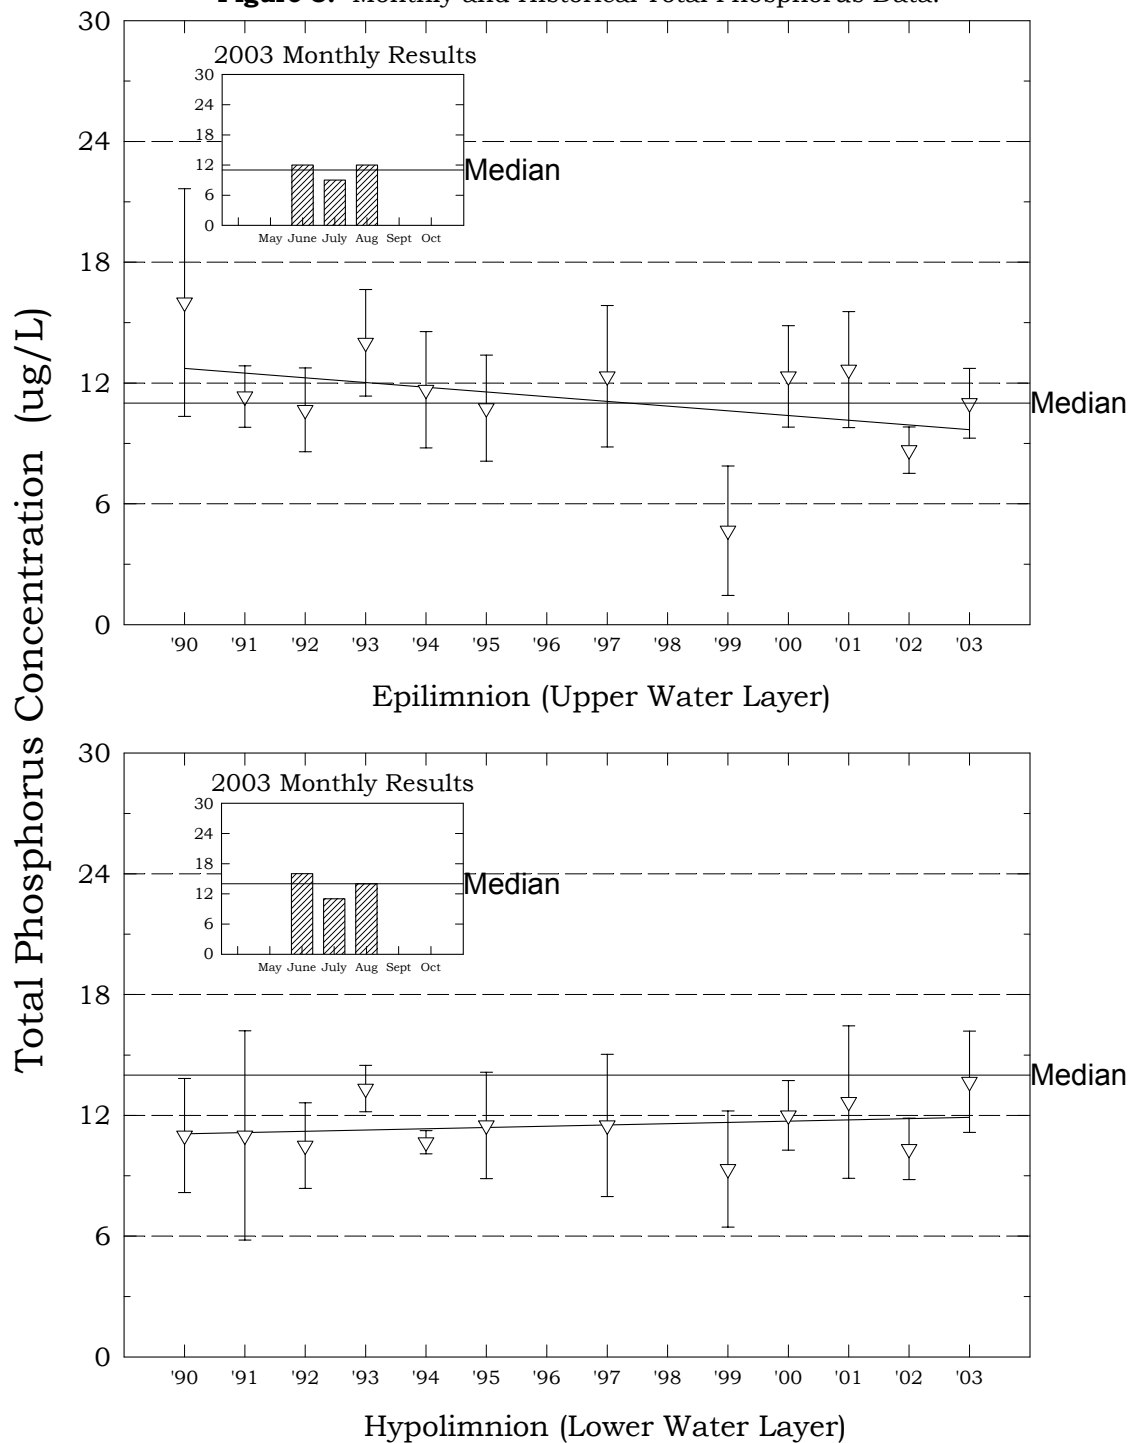
**Figure 3.** Monthly and Historical Total Phosphorus Data.

The current year data for the epilimnion (the top inset graph) and the hypolimnion (the bottom inset graph) show that the phosphorus concentration ***decreased slightly*** from June to July, and then ***increased slightly*** from July to August.

The historical data show that the 2003 mean epilimnetic and hypolimnetic phosphorus concentration is ***approximately equal to*** the state median.

Overall, visual inspection of the historical data trend line for the epilimnion and the hypolimnion show ***relatively stable*** phosphorus trend, (aside from the 1999 data point) which means that the concentration has ***remained approximately the same overall*** since monitoring began.

One of the most important approaches to reducing phosphorus loading to a waterbody is to continually educate watershed residents about its sources and how excessive amounts can adversely impact the ecology and value of lakes and ponds. Phosphorus sources within a lake or pond's watershed typically include septic systems, animal waste, lawn fertilizer, road and construction erosion, and natural wetlands.
